## MEMORANDUM

<b>To:</b>	Leslie McLean, King County Alex Shkerich, Atelier	<b>Date:</b>	May 16, 2005
<b>From:</b>	Jennifer Lowe & Rob McKenzie	<b>TG:</b>	03292.00
<b>CC:</b>			
<b>Subject:</b>	Burke-Gilman Trail Crossing Plan

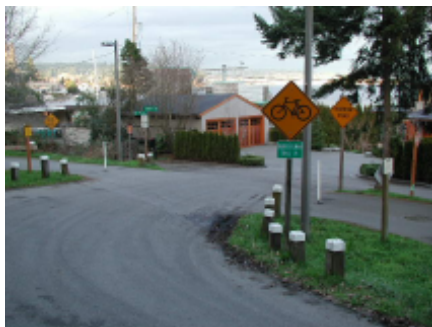
*Eastbound approach to intersection 1*

- Stop control for both directions of Path traffic.
- Bicycle warning sign W11-1 at the eastbound intersection approach.
- Single hinged tubular markers along the Path centerline on each side of the roadway.
- No Path pavement markings of any kind.
- No advance warning signs of any kind.
- Shrubbery and trees on the east side of the Path combined with a slight roadway grade, sloping down from the intersection towards Edgewater Lane limits the departure sight-distance for westbound vehicles.

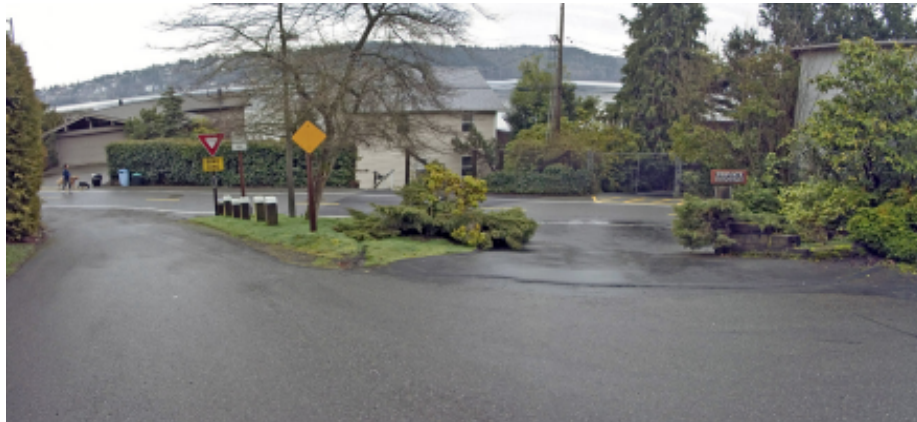
*Eastbound approach to intersection 2*

- Stop control for both directions of Path traffic.
- Multiple advance warning signs for Path users approaching from the south including; “warning- trail revisions ahead”, “caution vehicle traffic”, “caution crossings ahead” in combination with a 10mph speed limit sign, “caution hidden driveways ahead”, and MUTCD W3-1 stop ahead sign.
- Multiple advance warning signs for Path users approaching from the north including; “warning- trail revisions ahead”, “hidden driveways ahead use extreme caution”, and a 10mph speed limit sign.
- No warning or control signs for vehicles accessing the southern driveway

- Yield control for vehicles approaching the northern driveway from the west (This sign, in addition to the Stop sign for Path users, clearly conflicts with MUTCD standards regarding the use of only one type of regulatory control device at intersections).
- Single hinged tubular markers along the Path centerline on each side of the roadway. A striped, hatched diamond-shaped pattern painted on the pavement at the base of each tubular marker.
- Path pavement markings include:
  - Solid white lines indicating the Path edges through the intersection
  - A dashed yellow centerline through the intersection.
  - Rectangular areas outlined and hatched in yellow on the east side of the Path indicating driveway entrance areas.

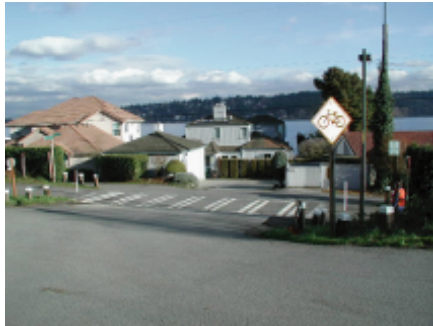
*Eastbound approach to intersection 3*

- Stop control for both directions of Path traffic.
- Bicycle warning sign W11-1 at the eastbound intersection approach.
- Motor vehicle prohibited sign for vehicles looking south, down the Path.
- Single hinged tubular markers along the Path centerline on each side of the roadway.
- Path is striped with a crosswalk treatment through the intersection.
- No advance warning signs of any kind.

- Shrubbery, trees, and hedges on the east side of the Path limit the departure sight-distance for westbound vehicles. Shrubs and trees on the west side of the Path are sight-distance obstacles for eastbound drivers.

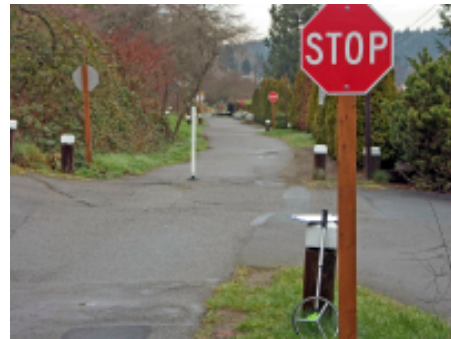
- Stop control signs for southbound Path traffic at intersections 4, 5, and 7.
- Stop control signs for northbound traffic at intersections 4, 5, and 6.

- Bicycle warning sign W11-1 at the eastbound intersection approach for intersection 7.
- Bicycle warning sign W11-1 oriented to be viewed by southbound Path traffic at intersections 4 and 5.

- “Caution hidden driveways ahead” signs for Path users approaching from the south, in advance of intersections 4 and 5.
- Single hinged tubular markers along the Path centerline on each side of driveway 4. One, single hinged tubular marker along the Path centerline north of intersection 7.

- No crosswalk striping treatment at any of these intersections.
- Shrubbery, trees, and hedges on the east side of the Path limit the departure sight-distance for westbound vehicles. Shrubs and trees on the west side of the Path are sight-distance obstacles for eastbound drivers.

*Northbound Path approach to intersection 4*

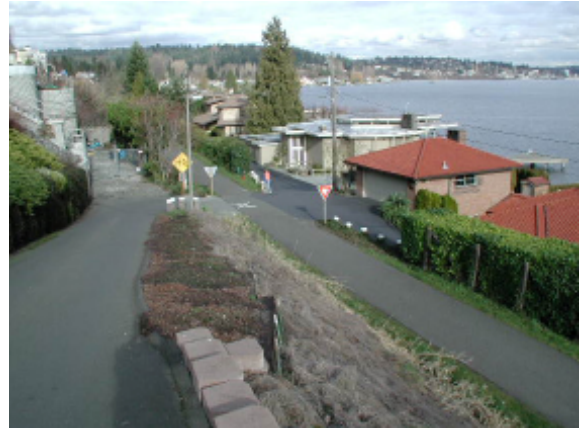
- Yield control for both directions of Path traffic.
- Bicycle warning sign W11-1 at the eastbound intersection approach.
- No Path pavement marking of any kind.
- No advance warning signs of any kind.
- Sight distance obstacles in this area include; hedges and fence near southeast corner, and hedges near northeast corner.

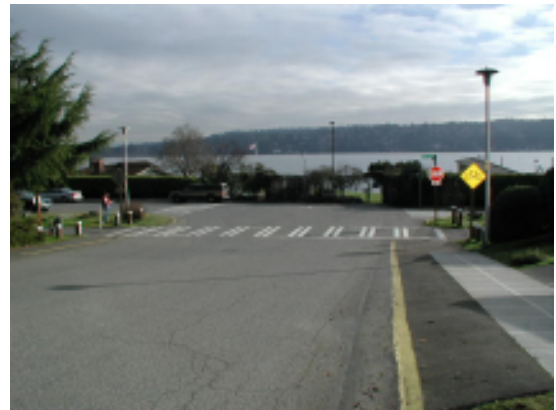
- Stop control for both directions of Path traffic and for vehicles on the east/west legs as well.
- Bicycle warning sign W11-1 at both the eastbound and westbound approaches.
- Single hinged tubular markers along the Path centerline on each side of the roadway.
- Path is striped with a crosswalk treatment through the intersection.
- No advance warning signs of any kind.
- Trees and hedges on the southwest

*Eastbound approach to intersection 9*

corner of this intersection are sight-distance obstacles for eastbound drivers.

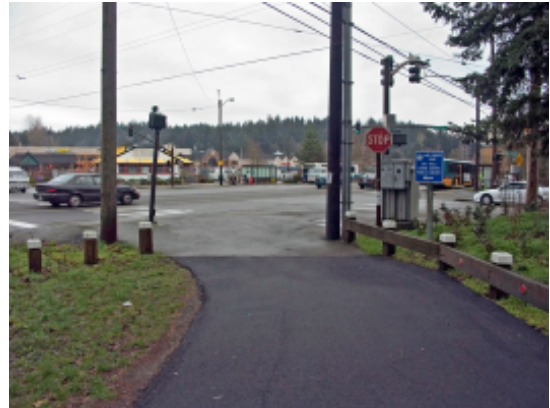
- Signalized control for all vehicle and non-motorized intersection approaches.
- Push-button actuated pedestrian signals for Path users.
- Stop signs for Path users are located where the Path joins the sidewalk.
- “Stop Ahead” warning sign for southbound Path traffic in advance of intersection.
- Crosswalk striping on the roadway through the intersection.

*Northbound Path approach to intersection 10*

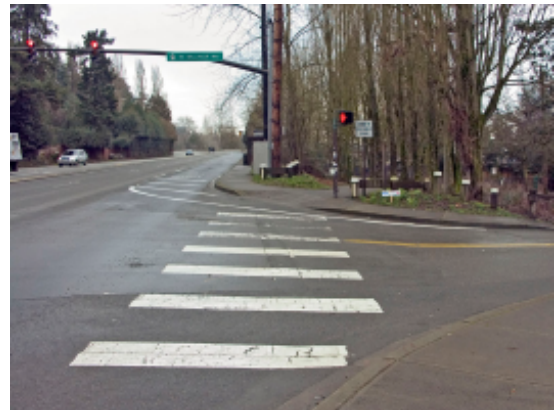
- Signalized control for all vehicle and non-motorized intersection approaches.
- Push-button actuated pedestrian signals for Path users.
- “Caution heavy vehicle traffic” warning sign for northbound Path traffic in advance of intersection.
- “Obey Crosswalk Signal” sign for both directions of Path traffic located on the opposing intersection corners (see photo).

*Northbound Path approach to intersection 11*

- Crosswalk striping on the roadway through the intersection.

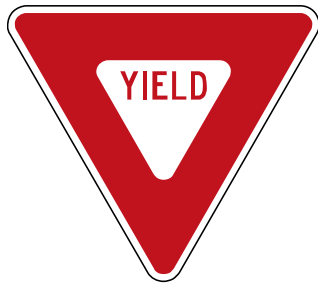
### **Yield Sign (R1-2)**

YIELD signs may be used instead of STOP signs if engineering judgment indicates that one or more of the following conditions exist:

A. When the ability to see all potentially conflicting traffic is sufficient to allow a road user traveling at the posted speed, the 85th-percentile speed, or the statutory speed to pass through the intersection or to stop in a reasonably safe manner.

B. If controlling a merge-type movement on the entering roadway where acceleration geometry and/or sight distance is not adequate for merging traffic operation.
